# Transportation Synthesis Report

## Overlay of Shoulder Rumble Strips

**Preparation of Rumble Strips Prior to Overlayment –  
Research Project No. 13733V**  
(Document courtesy of Denis Boisvert, NHDOT, [dboisvert@dot.state.nh.us](mailto:dboisvert@dot.state.nh.us))

**Preparation of Rumble Strips Prior to Overlayment –  
Research Project No. 13733V  
Test Site Inspection – July 21, 2005**

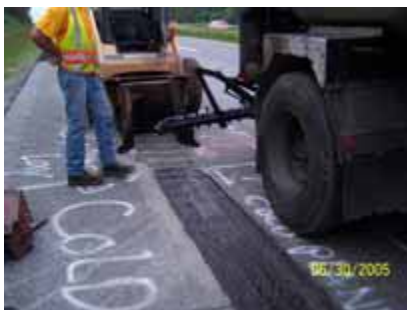
### **Preparation of Rumble Strips Before Overlayment**

Since the use of continuous shoulder rumble strips is relatively new (mid to late 1990s), rehabilitation of the pavements where they have been installed is just beginning. NH performed its first thin (1-inch) overlay of rumble strips during the 2003 construction season. The rumbles immediately reflected through the new pavement. Inquiries to other state DOTs indicated a range of opinions on preparation techniques, from grinding the strip and shimming before paving, to doing nothing provided the overlay is more than 4 inches. The objective of this project is to develop a specification or guideline defining materials, sequences and/or options to perform this operation successfully and economically. Four preparation scenarios were selected and incorporated into a paving project on I-89 in Enfield. Test sections five hundred feet in length were installed in July 2005. Monitoring of the overlay will extend over at least one winter before new rumbles are milled in the same location.

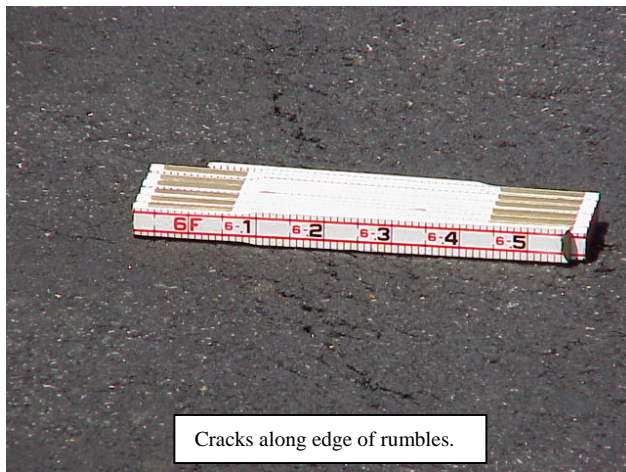
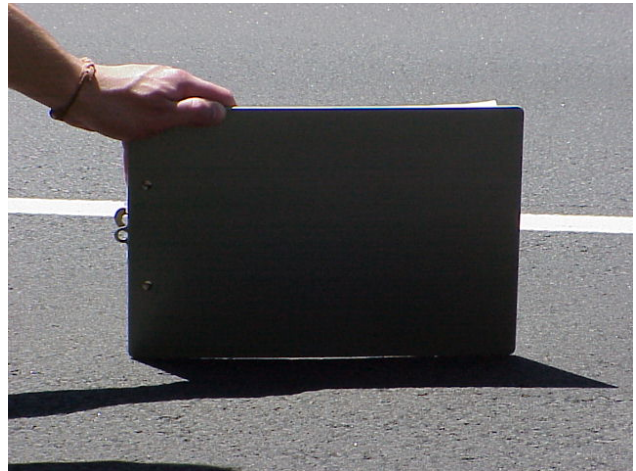
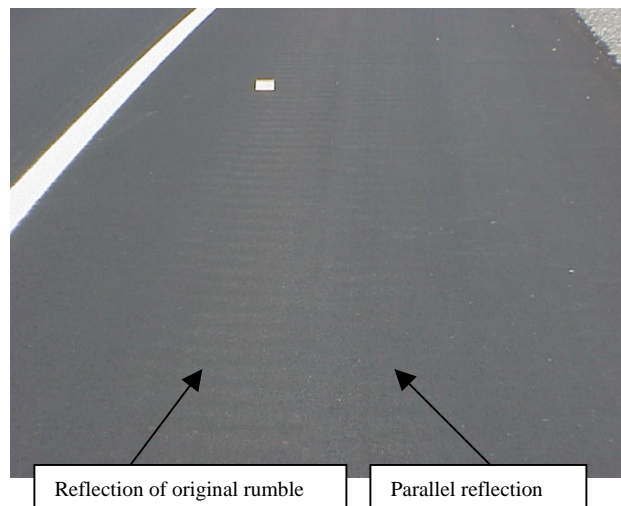
Section B (just overlay) showed occasional longitudinal cracks along the edge of the rumble strip, indicating movement of the mix by the roller through the affected rumble. The rumble strip had reflected through the overlay along the entire length of this section. Additionally, a parallel line of “reflected” rumbles was observed in this section. Mr. Lathrop interprets that the vibratory roller drum bounces due to the alternating mix thickness in the rumble strip, resulting in the indentation of the surface alongside of the original rumble strip.

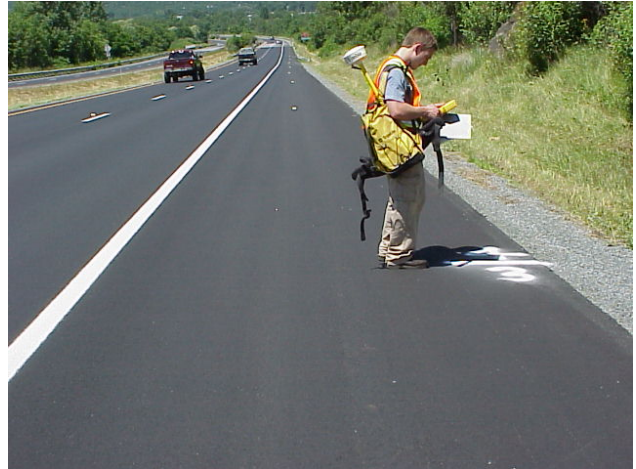
Section C (mill, inlay and overlay) showed no reflection of the milling, which would have displayed as a rut.

Section D (mill and overlay) also showed no sign of the former rumble strip.

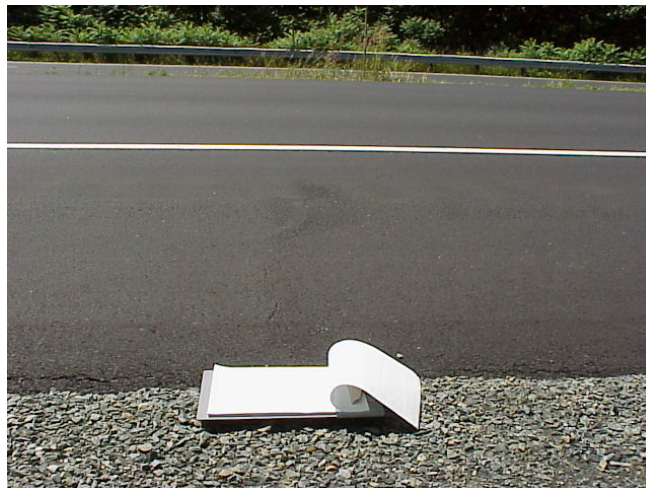
General: Occasional lateral cracks were observed in the shoulder. Mr. Lathrop indicated that they were common in overlay projects, and is not associated with the rumble strip overlay. He explained that the crack seal material in the existing pavement is heated by the new overlay mix, expands, and cracks the overlay pavement before it cools, causing an immediate defect.

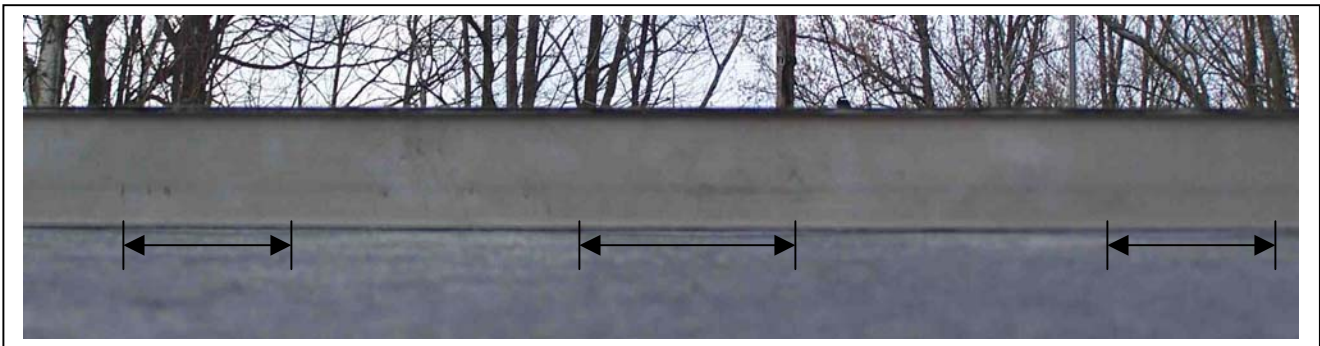
**Section A (shim and overlay)** showed no indication of rumble strip reflection last July. However, mild depressions are now visible (see below), due mainly to the abrasion of the snowplows on the rumble strip bars. The bars are also felt when driven upon.

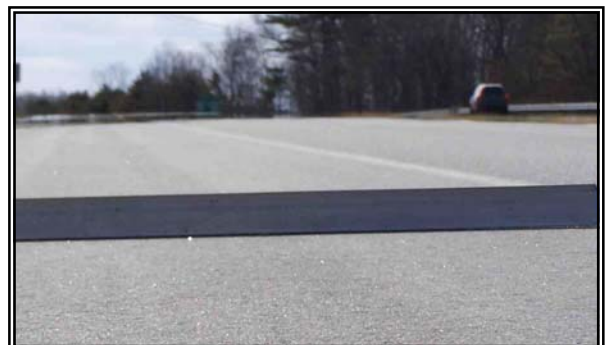
**Section C (mill, inlay and overlay)**, which includes the greatest number of steps to accomplish, still shows no reflection of the milled area, which would have displayed as a rut. Left, the outline of the former rumble strip is vaguely visible on the shoulder surface.
